Derailment of Coal Train EG37

Connors Range

1 July 2001

This report was jointly produced by the Australian Transport Safety Bureau (ATSB), Queensland Transport and Queensland Rail (QR).

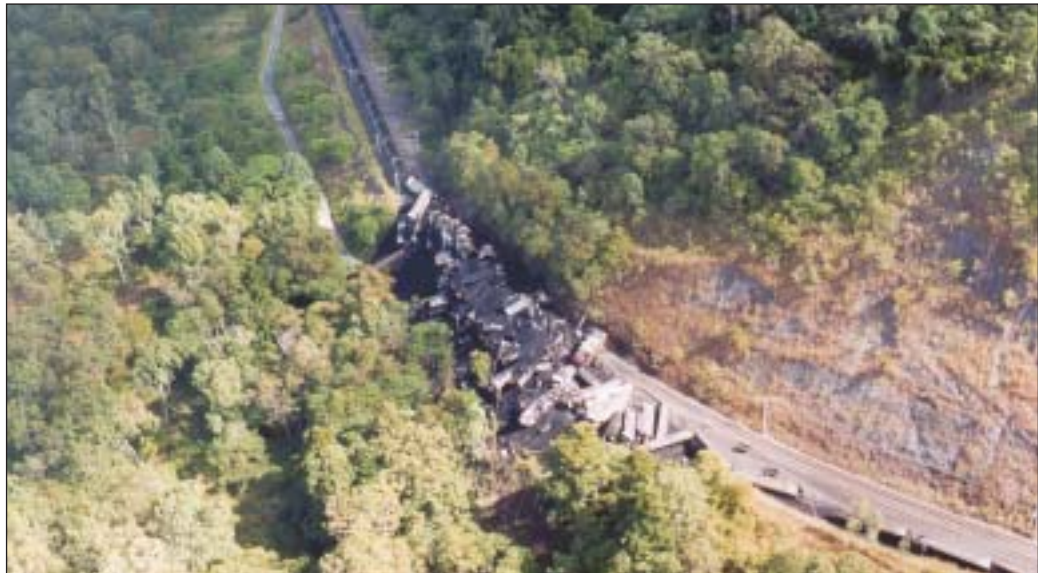
Figure 3:
General view of accident site

Within seconds of separating from the rest of the train, the front portion of the EG37 commenced to rapidly decelerate. It stopped some 123 seconds later and approximately two kilometres beyond the point of separation.

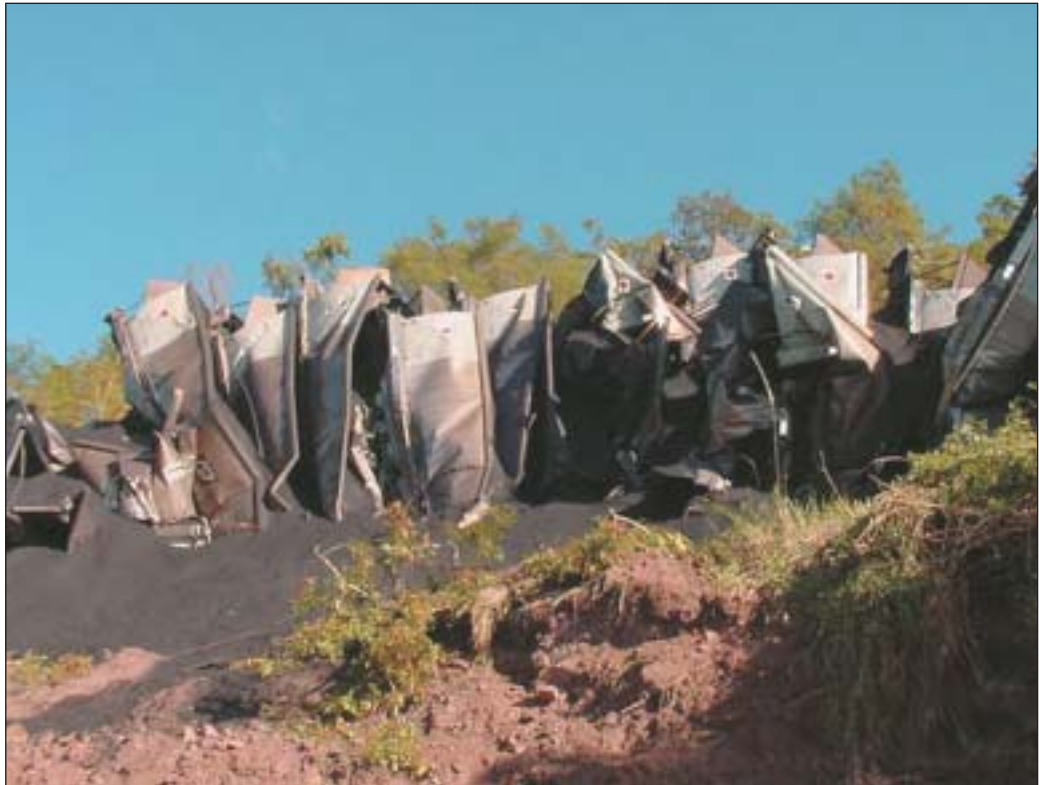
The main wreckage, including 73 wagons, the two remote locomotives and the ELRC, was confined within a distance of 276 m (The normal operating length of that part of the train prior to the accident was 1,211.7 m). Several wagons were 'stacked' vertically (see fig. 6) and many others were 'buried' under other wagons and coal (see fig. 7). They had all experienced significant impact forces during the accident sequence and were substantially damaged. However, the main portion of the ELRC was relatively undamaged and was located on top of several wagons (see fig. 8).

Figure 6:
View of derailment site showing several wagons 'stacked' vertically

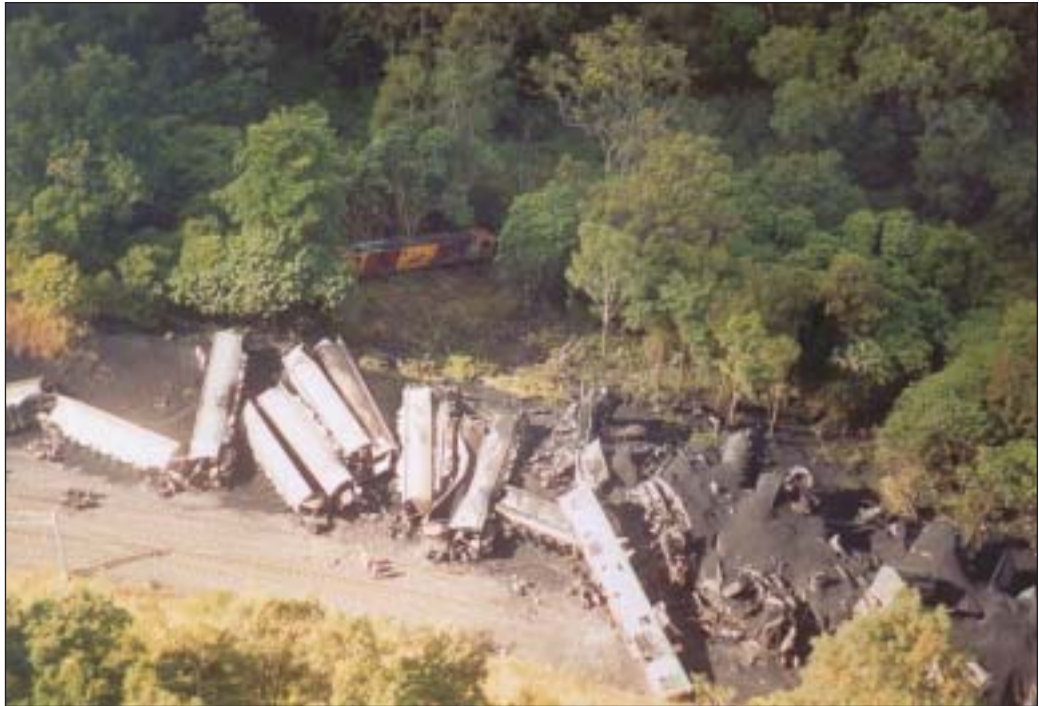
Figure 7:
View of derailment site showing several wagons 'buried' under coal and other wagons

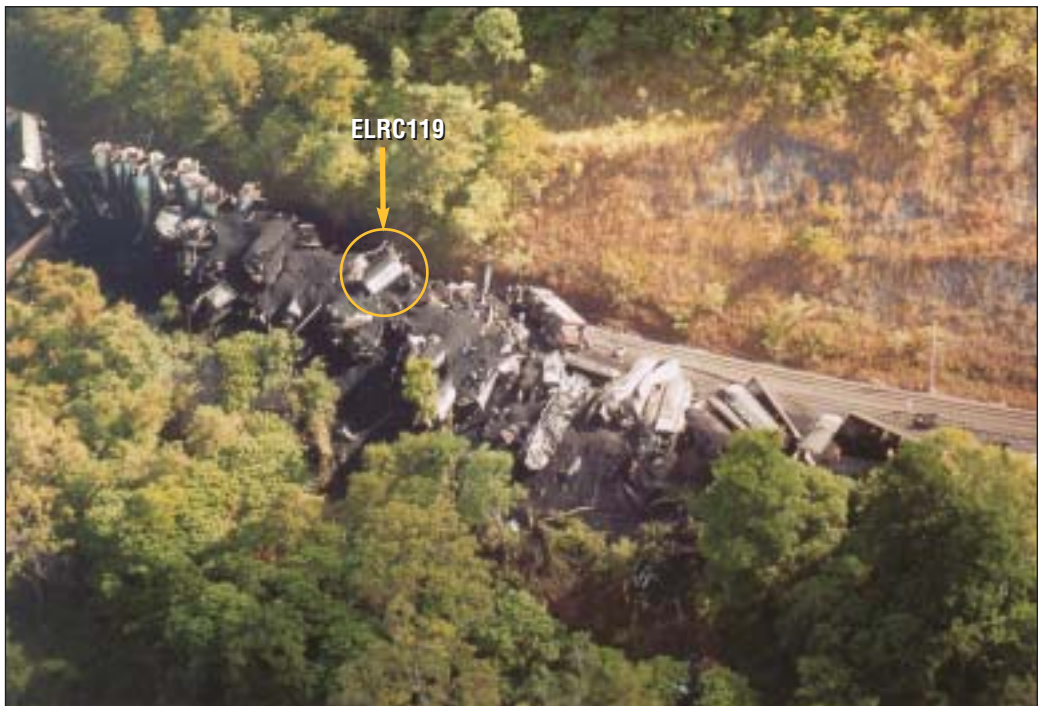
Figure 8:
View of derailment site showing ELRC119 'perched' on top of several wagons

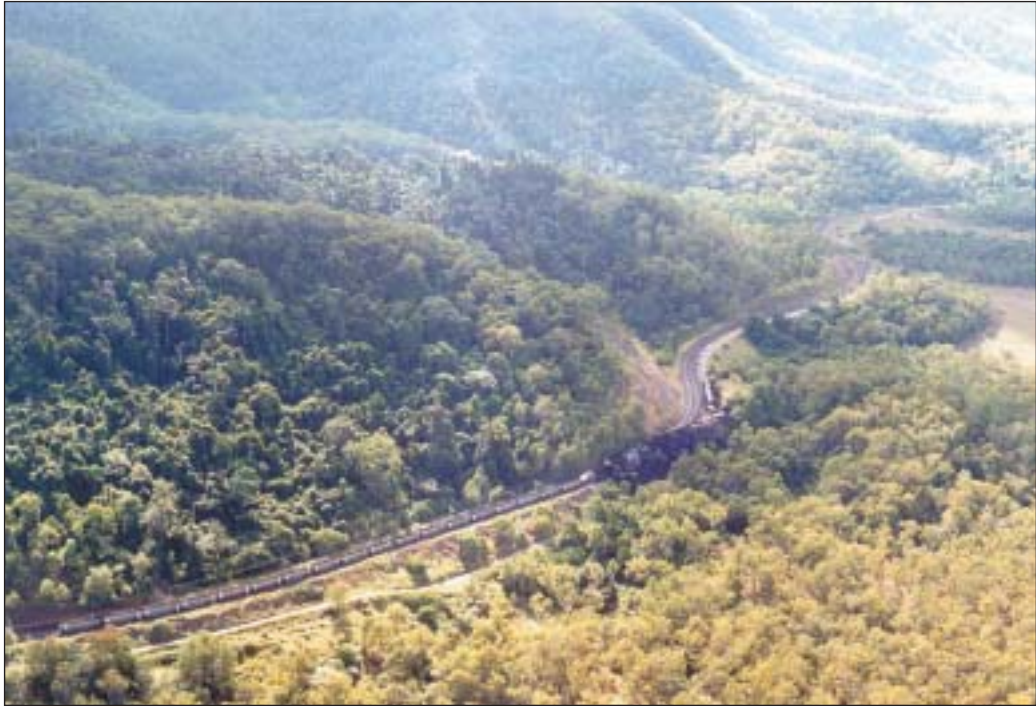
The trailing 18 wagons of EG37 remained on the track after the derailment. Those wagons were later attached to a diesel locomotive and taken back up the Connors Range where they were stowed at Hatfield (see fig. 9).

Figure 9:
View of derailment site showing trailing 18 wagons, which remained on the track

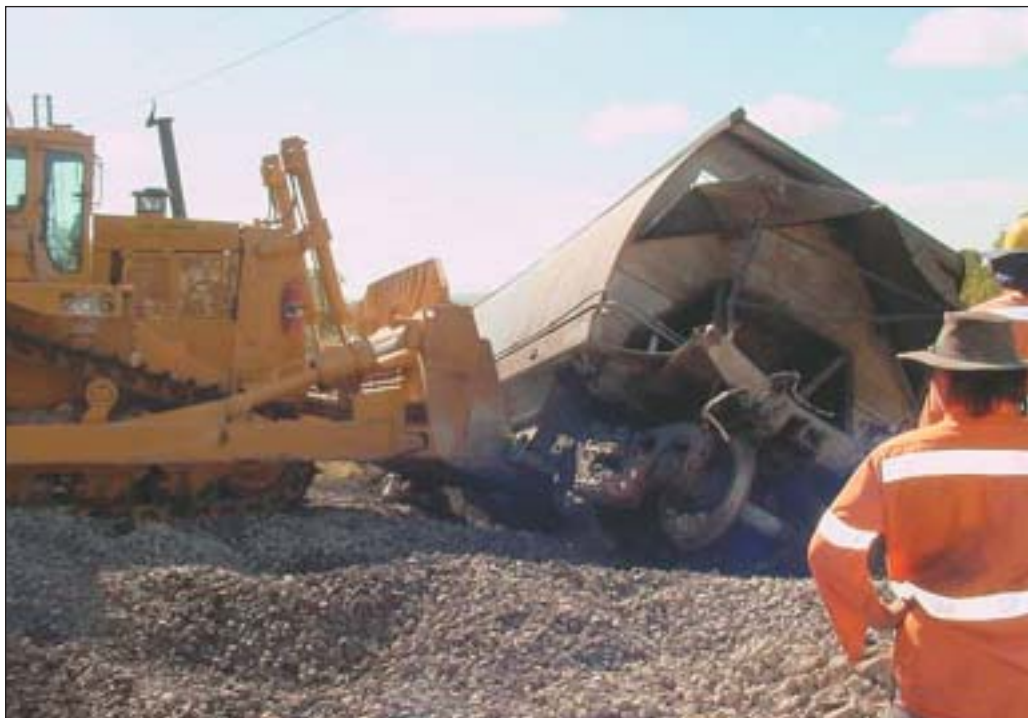
Figure 10:
Recovery operation in progress

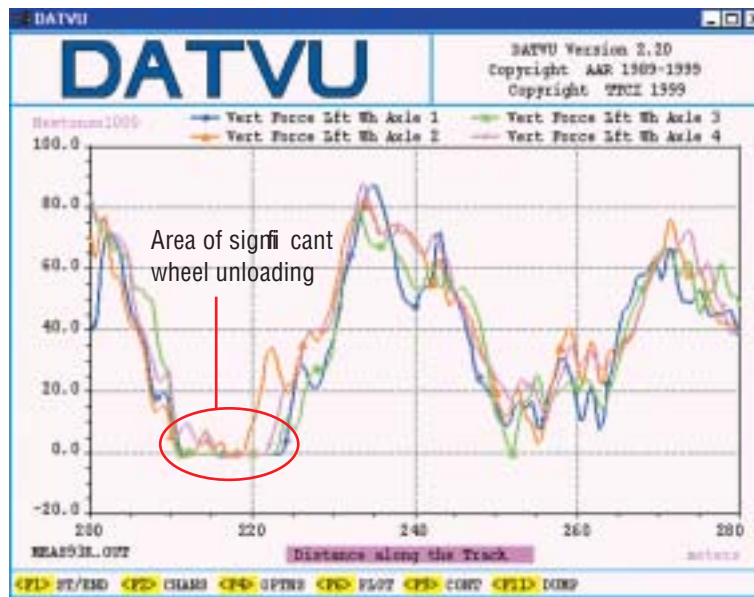
It was concluded from the simulations that the cause of derailment was dynamic overturning of one or more wagons at a speed of 93 km/h. That dynamic overturning occurred about the high rail at the end of the entrance transition of the curve approximately 37.59 km from Hay Point. The resultant forces were affected in part, by minor variations to the correct cant and curvature of the track at that location.

Figure 14:
NUCARS simulation showing total unloading of wheels on the low rail for approximately 10 m in area of derailment

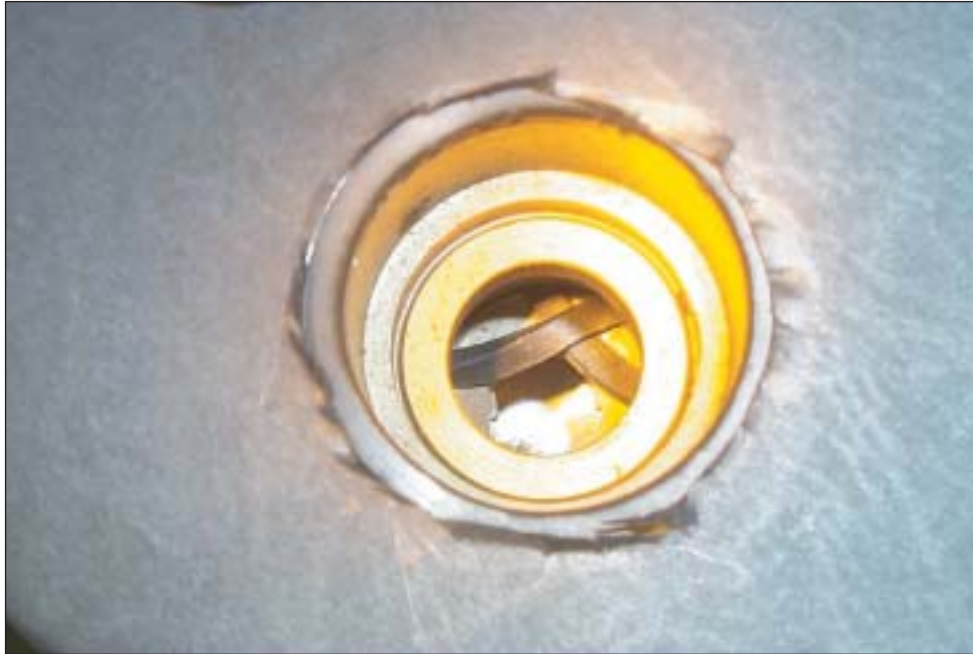
Upon disassembly of the Brake Pipe Control Valve, an errant square-section O-ring was observed to be lodged in a figure-8 shape across the seat of the Brake Pipe cut off portion of the valve and was holding the Brake Pipe Cut-Off Valve open (see fig. 16). This would have been the case even if the Main Reservoir air through '53A' were trying to close the valve (see fig. 17).

Figure 16:
Errant O-ring found lodged in seat of cut off portion of the Brake Pipe Control Valve on ELRC119

In normal train operations, recharging the Brake Pipe via that valve causes a large volume of air to pass through that port. It was considered that this would be sufficient to cause the O-ring to pass into the seat area of the cut off portion of the valve.

In a test of Brake Pipe recharges, an O-ring lodged under the valve seat and formed a figure 8, consistent with what was observed in the Brake Pipe Control Valve found in EG37.

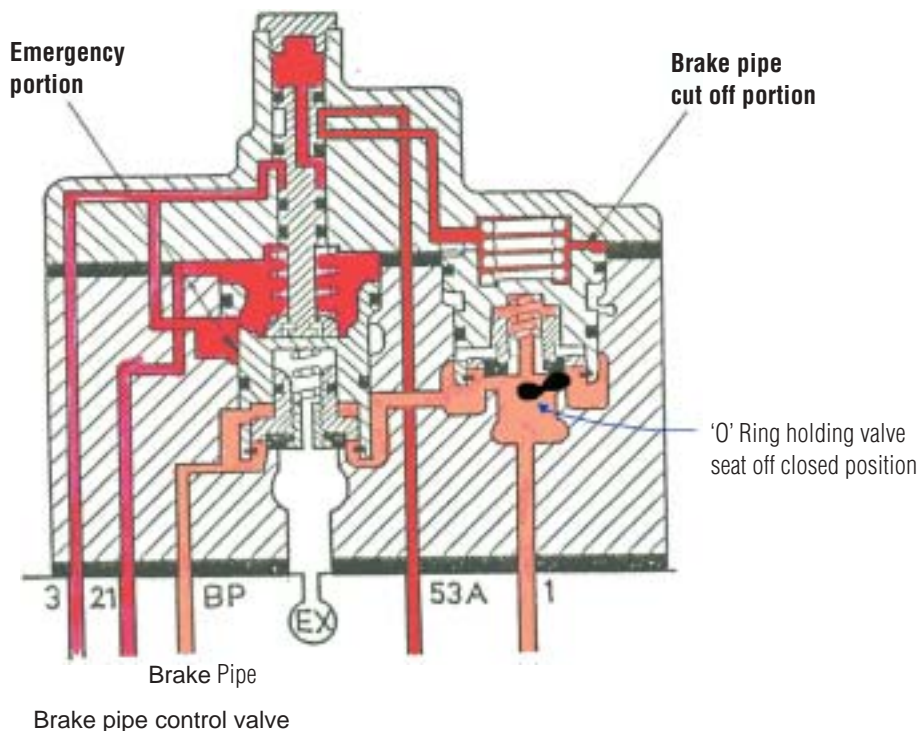
Figure 17:
Schematic diagram showing how errant o-ring prevented normal cut off function of Remote Feed Valve

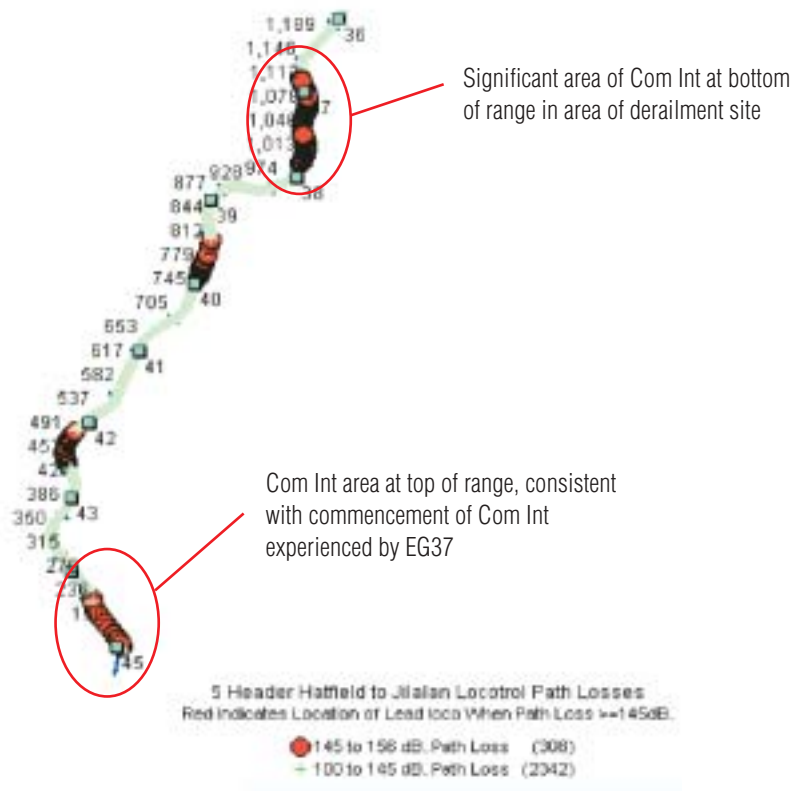
The results of those tests indicated that there were two significant areas of communications interruptions of varying duration and some other smaller areas (see fig. 19). The reason for the loss of radio signal was considered to be terrain shielding. Note that the tests were completed following the accident on trains travelling at modified speeds (maximum 35 km/h). It was therefore considered more likely that longer and more frequent communication interruptions would be evident during those tests.

Figure 19:
Locotrol 'Path Loss' Black Mountain 45 to 36 Km. 5-Header train travelling down the range

One of the significant communications interruption areas identified during the tests was consistent with the area reported by the Driver of EG37 as being the location where the Com Int commenced. That location was also consistent with reports from other Drivers.

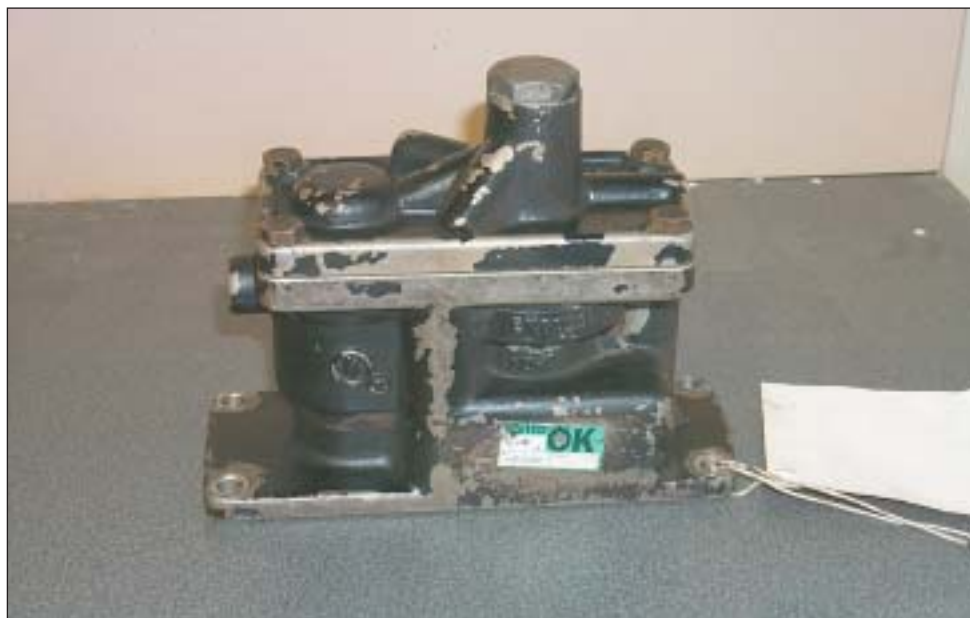
As previously stated, Brake Pipe Control Valves undergo a 144-week cycle of overhaul and inspection including the replacement of certain items such as all O-rings. A sticker on the outside of the Brake Pipe Control Valve from ELRC119, indicated that the unit had been overhauled and 'Tested OK' on 19 January 2000 (see fig. 20).

Figure 20:
Brake Pipe Control Valve from ELRC119
