Derailment of Coal Train EG37

Connors Range

1 July 2001

This report was jointly produced by the Australian Transport Safety Bureau (ATSB), Queensland Transport and Queensland Rail (QR).

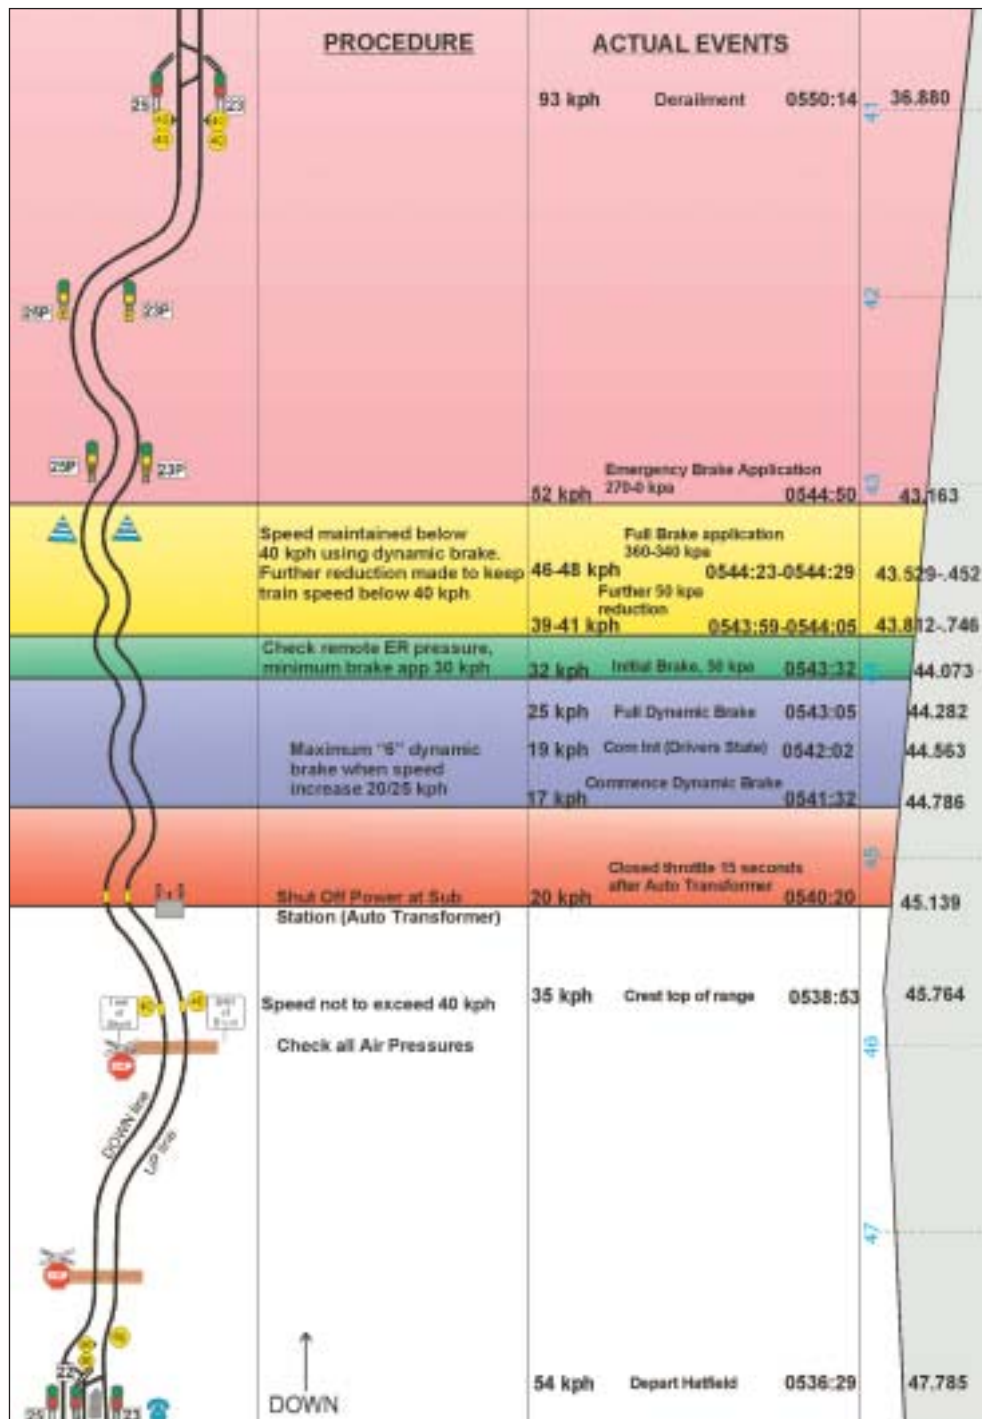
Figure 4:
Comparative presentation of written procedure for handling trains down Connors Range and actual events relating to EG37

At the Point of Balance⁹, EG37 had slowed to its lowest speed of 17 km/h. At that time, the Driver commenced to engage Dynamic Brake. Over a period of about one and half minutes, the Driver continued to increase Dynamic Brake. The train commenced to accelerate slowly during that time. Before Dynamic Brake had been fully applied, the Driver reported that the Locotrol display indicated that a communications interruption (Com Int) had occurred (see fig. 2). The red Com Int warning light was illuminated and the Dynamic Brake indication was flashing at Dynamic Brake level '8'.

Route-specific instructions on how to handle trains whilst descending the Connors Range are also provided to Drivers. Those instructions have been referred to for comparative analysis of the Driver's actions and are contained in figure 4. Those instructions do not refer specifically to handling a train while in a state of Com Int on the range. However, amended procedures that were introduced following the derailment, provide directions to Drivers about what actions to take if a Com Int is experienced.

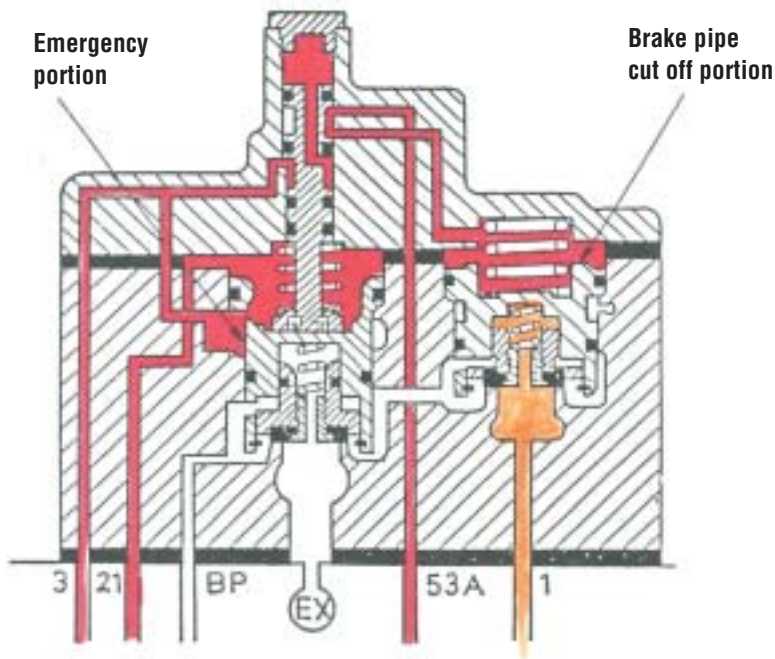
Figure 12:
Schematic of Brake Pipe Control Valve during Remote Feed Valve 'cut out'

When the Feed Valve 'cut out' command is given, Feed Valve 'cut out' is achieved by delivering Main Reservoir²⁰ air pressure into the '53A' pipe, which connects to the cut-off portion of the Brake Pipe Control Valve (see fig. 12). This action results in the Train Brake Pipe being sealed at the ELRC and prevents any further Train Brake releases or applications by the ELRC. The train then becomes a 'head-end-only'²¹ train, but is still under the control of the Driver. All Train Brake applications and releases are then propagated only from the front of the train and not also from the ELRC.

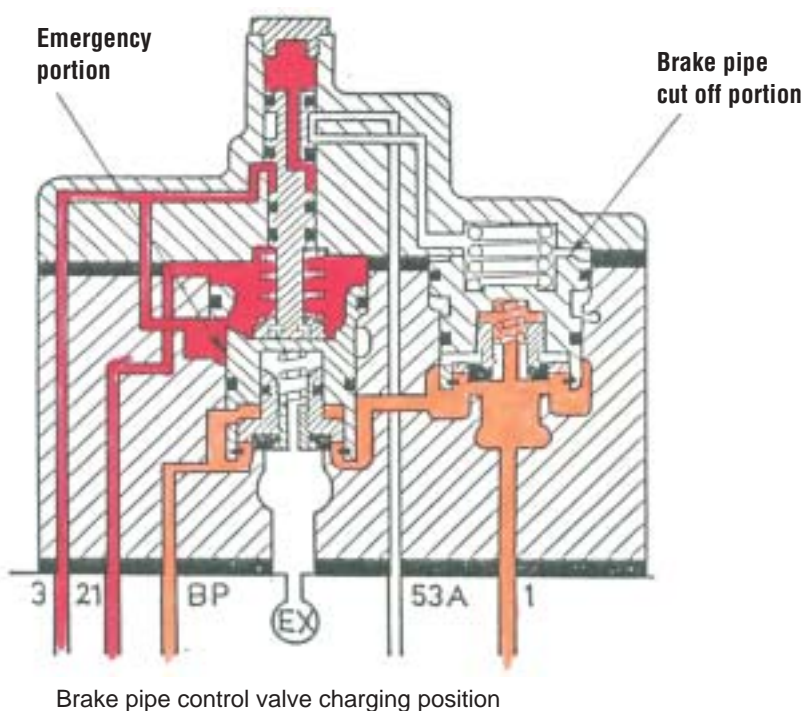
Figure 13:
Schematic of Brake Pipe Control Valve with Remote Feed Valve 'cut in'

When Locotrol radio communications are operating normally via Data Radios as previously described, and with the Feed Valve 'cut in', the Brake Pipe Control Valve is open and allows air to flow freely between the Brake Pipe and the Relay Valve in the ELRC (see fig. 13). The Relay Valve is controlled by the Driver's actions in the lead locomotive. Train Brake applications and releases made by the Driver in the lead Locomotive, are mirrored in the ELRC. If the Driver commands Feed Valve out (for example, as part of a normal test procedure) or the Remote Feed Valve in the ELRC cuts itself out for some reason, the Driver would receive a Feed Valve OUT indication on his Locotrol console. During a state of Com Int, however, a Driver does not receive real-time information about the status of the Remote Feed Valve.

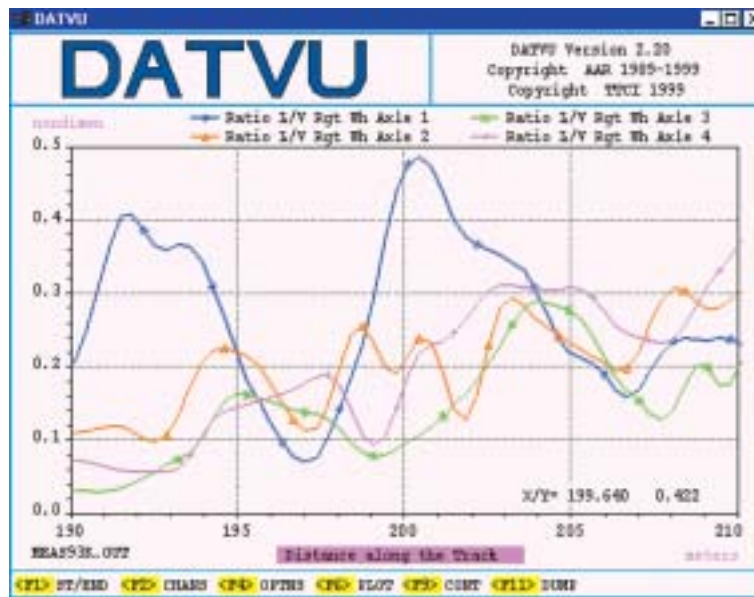
Figure 15:
Results of L/V ratios in area of derailment

The lateral to vertical force ratio (L/V)²⁹ for the leading wheels on the high rail³⁰ reached a maximum (sustained for 2 m) of only 0.42, indicating that it was unlikely that the derailment was a result of flange climb (see fig. 15).
